# FINAL WATTS BRANCH WATERSHED ASSESSMENT

September 2015

City of Rockville, Maryland  
Department of Public Works

BayLand Consultants & Designers, Inc.

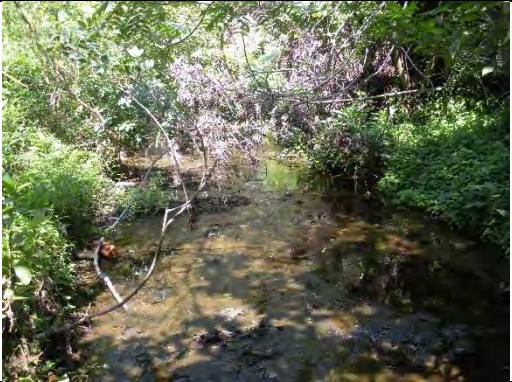
<b>Table 3.2</b> <b>Summary of Observed Hotspots</b>		
Site	Observed Problem(s)	Example
Stream Reach 103	<ul style="list-style-type: none"> <li>Algae (an indicator of nutrient pollution) was observed in Reach 103 near the Tennis Courts in Glenora Park</li> </ul>

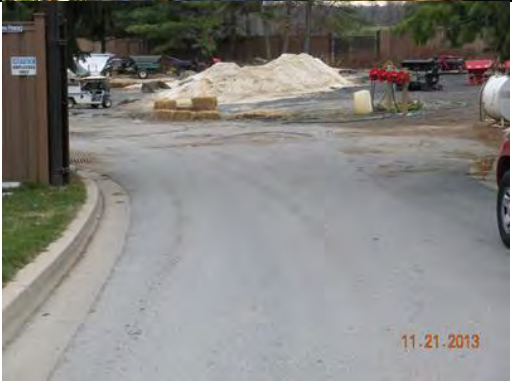
Lakewood Golf Course	<ul style="list-style-type: none"> <li>Uncovered piles of sand; runoff from the site could potentially flow into a nearby stream</li> <li>Potential overuse of fertilizers and pesticides for turf management (this type of land use generally is common, but the nutrient management plan is unknown).</li> <li>Algae growth in Reach 102 and 201</li> </ul>

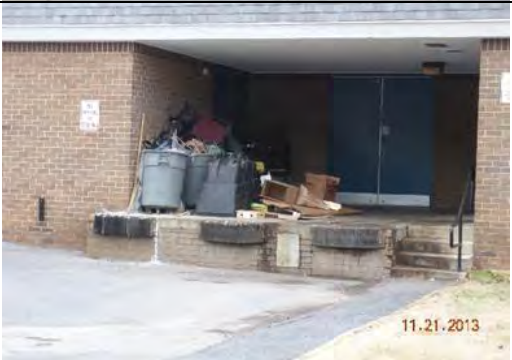
Robert Frost Middle School	<ul style="list-style-type: none"> <li>Overflowing trash receptacles; trash could runoff into a nearby stream</li> </ul>

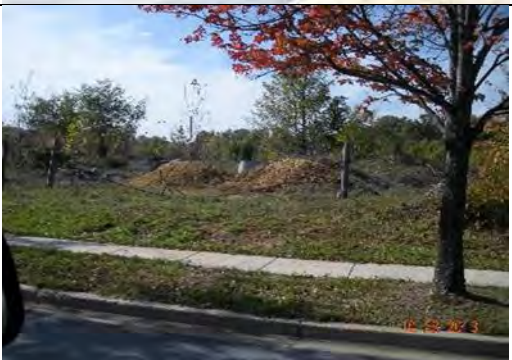
Research Boulevard Sediment Stockpile Area (future development site for Falls Grove offices)	<ul style="list-style-type: none"> <li>Uncovered piles of soil, gravel, and other materials on site; runoff from the site could potentially flow into a nearby stream</li> </ul>

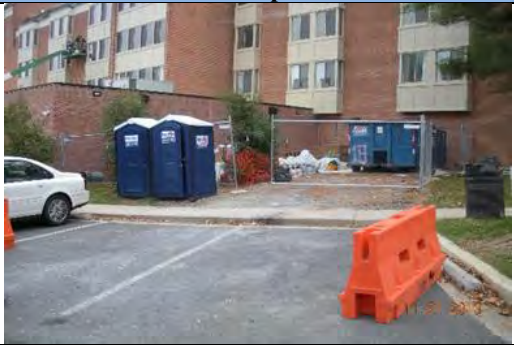
Table 3.2 Summary of Observed Hotspots		
Site	Observed Problem(s)	Example
The Village at Rockville Lutheran Community	<ul style="list-style-type: none"> <li>Potential chemical runoff from exposed paint and other containers at Lutheran Community Center</li> </ul>

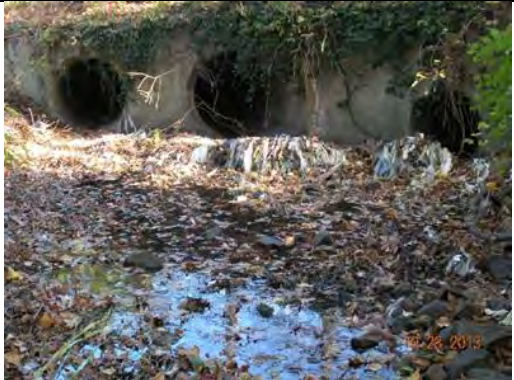
Research Boulevard - Westat Business Complex	<ul style="list-style-type: none"> <li>Trash and sediment built up near outfalls and along entire reach through an office area on Reach 108</li> </ul>
